Creep and Failure of Palaeozoic-Rock Slope

KOBAYASHI, Yoshimasa; NAKAGAWA, Akira

KOBAYASHI, Yoshimasa ...[et al]. Creep and Failure of Palaeozoic-Rock Slope. Bulletin of the Disaster Prevention Research Institute 1974, 24(3): 205-216

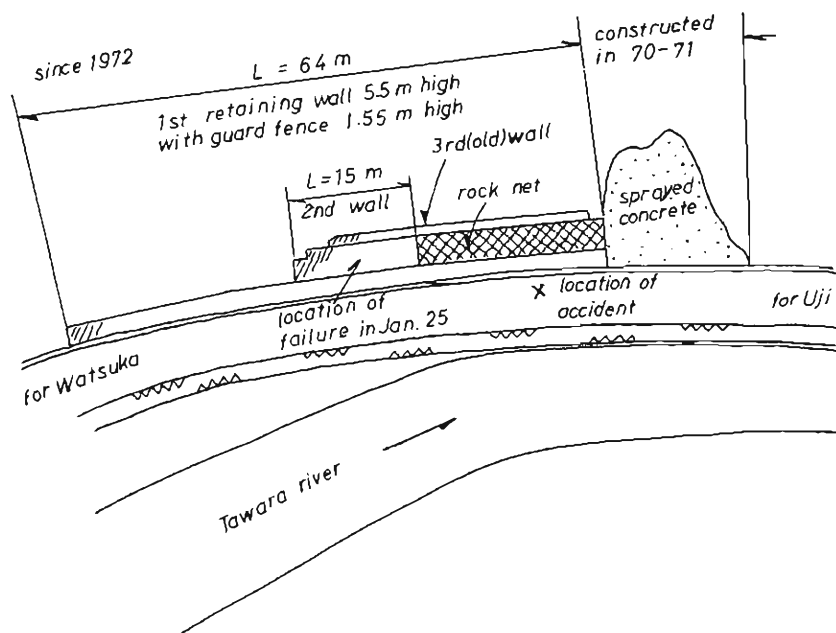
A retaining wall as illustrated in Fig. 1 had been nearly completed when the rockfall occurred, and some effect of the work on the accident was first suspected.

Fig. 1. Schematic representation of preventive works against rockfalls and slope failures at the site.

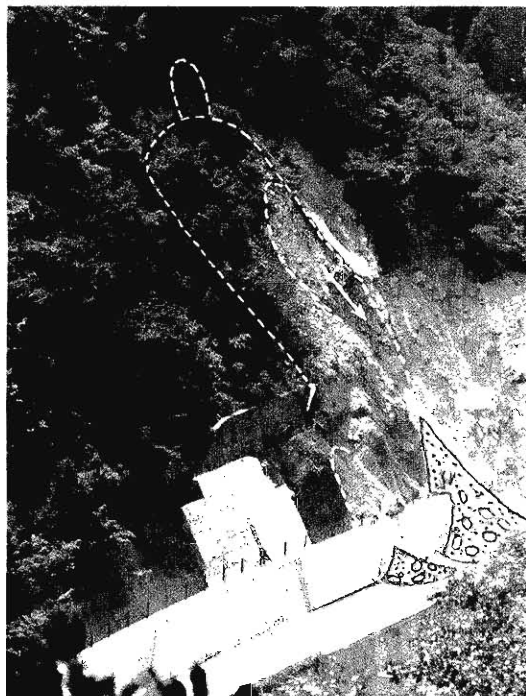
Fig. 5. View of the site.
